# **Overview of the Third Quarter 2009 Surveillance and Maintenance Report for the LM Rocky Flats Site**

# Pond Operations – Third Quarter 2009

# Hydrologic Data – Third Quarter 2009

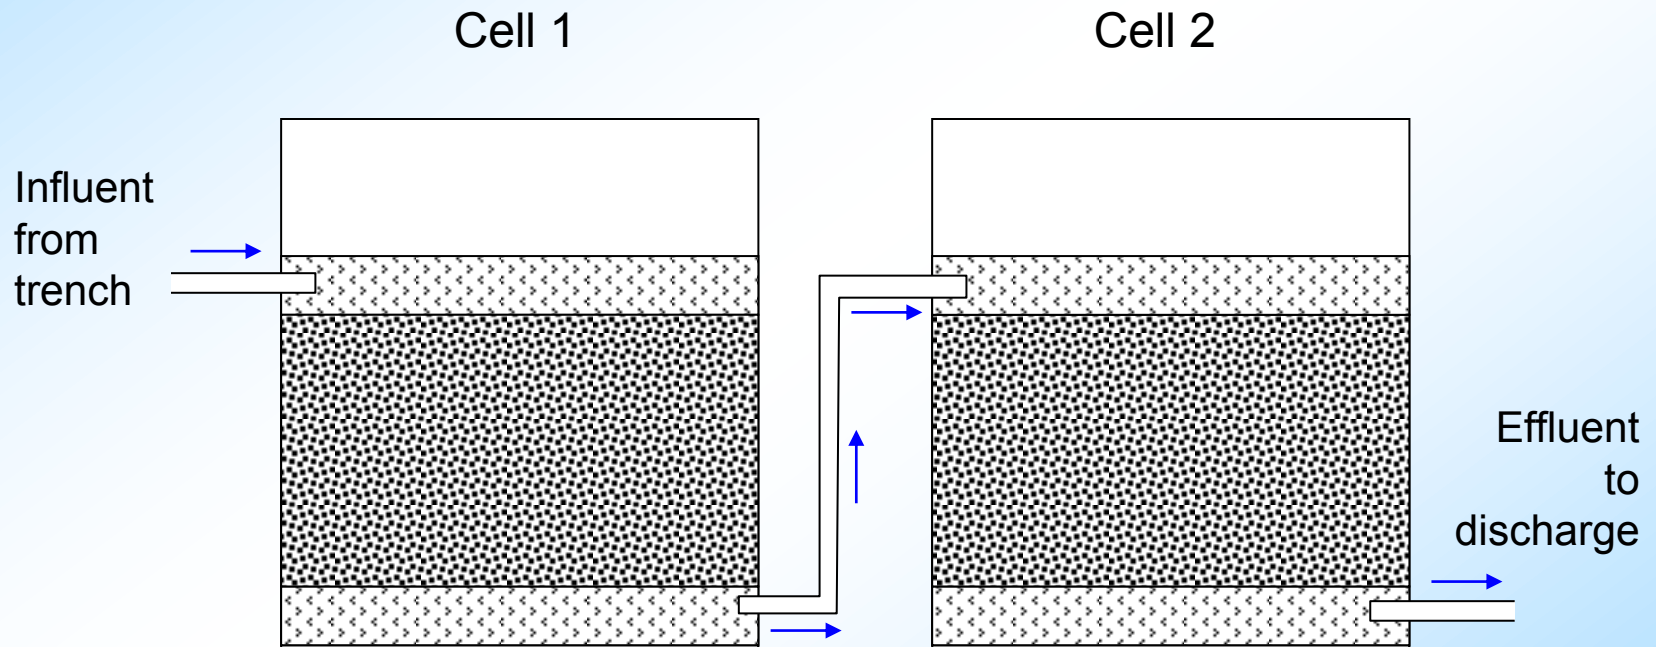
- Previous configuration: series, downflow

- Cell 1 media clogs or becomes ineffective more rapidly and more thoroughly than Cell 2 media
- Media replacement is required sooner
- Cell 2 media gets replaced before it really needs it (cost efficiencies in mobilization/demobilization, labor, equipment, etc.)

- Media more readily develops preferential pathways (water trickles downward with gravity assistance, rather than seeping upward against gravity)
- Cannot push more water through the system than media permeability allows – water will simply overtop the cell
- Must replace media as dictated by media permeability (clogging) rather than by effluent water quality

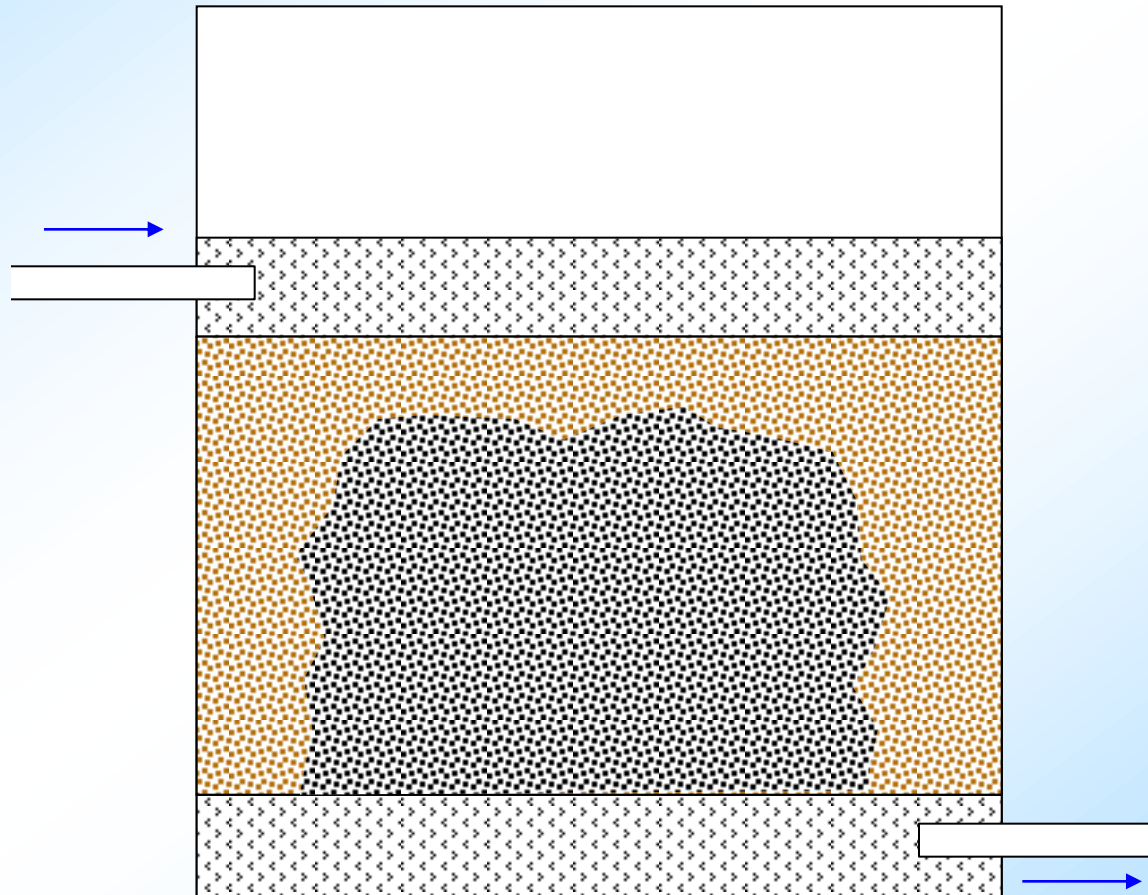
- Much of central portion of media was not oxidized; was ineffective in water treatment

- Addressed short-circuiting and improved treatment effectiveness
  - Redesigned media
  - Used improved distribution gallery design
  - Changed primary operating configuration
- Prepared for next media replacement
  - Installed liner around inside of cell so media will not adhere to cell walls (in the past, has required jackhammer to remove)
- Reduced long-term maintenance needs
  - Eliminated buried valves (can cause problems; SPPTS in 2006)
  - Installed new flow-control vault directly between cells (easy access, eliminates pipe “spaghetti” that can lead to clogging)
  - Most pipes are now inside pipe liners; if clogging develops, can easily replace during media replacement without excavating

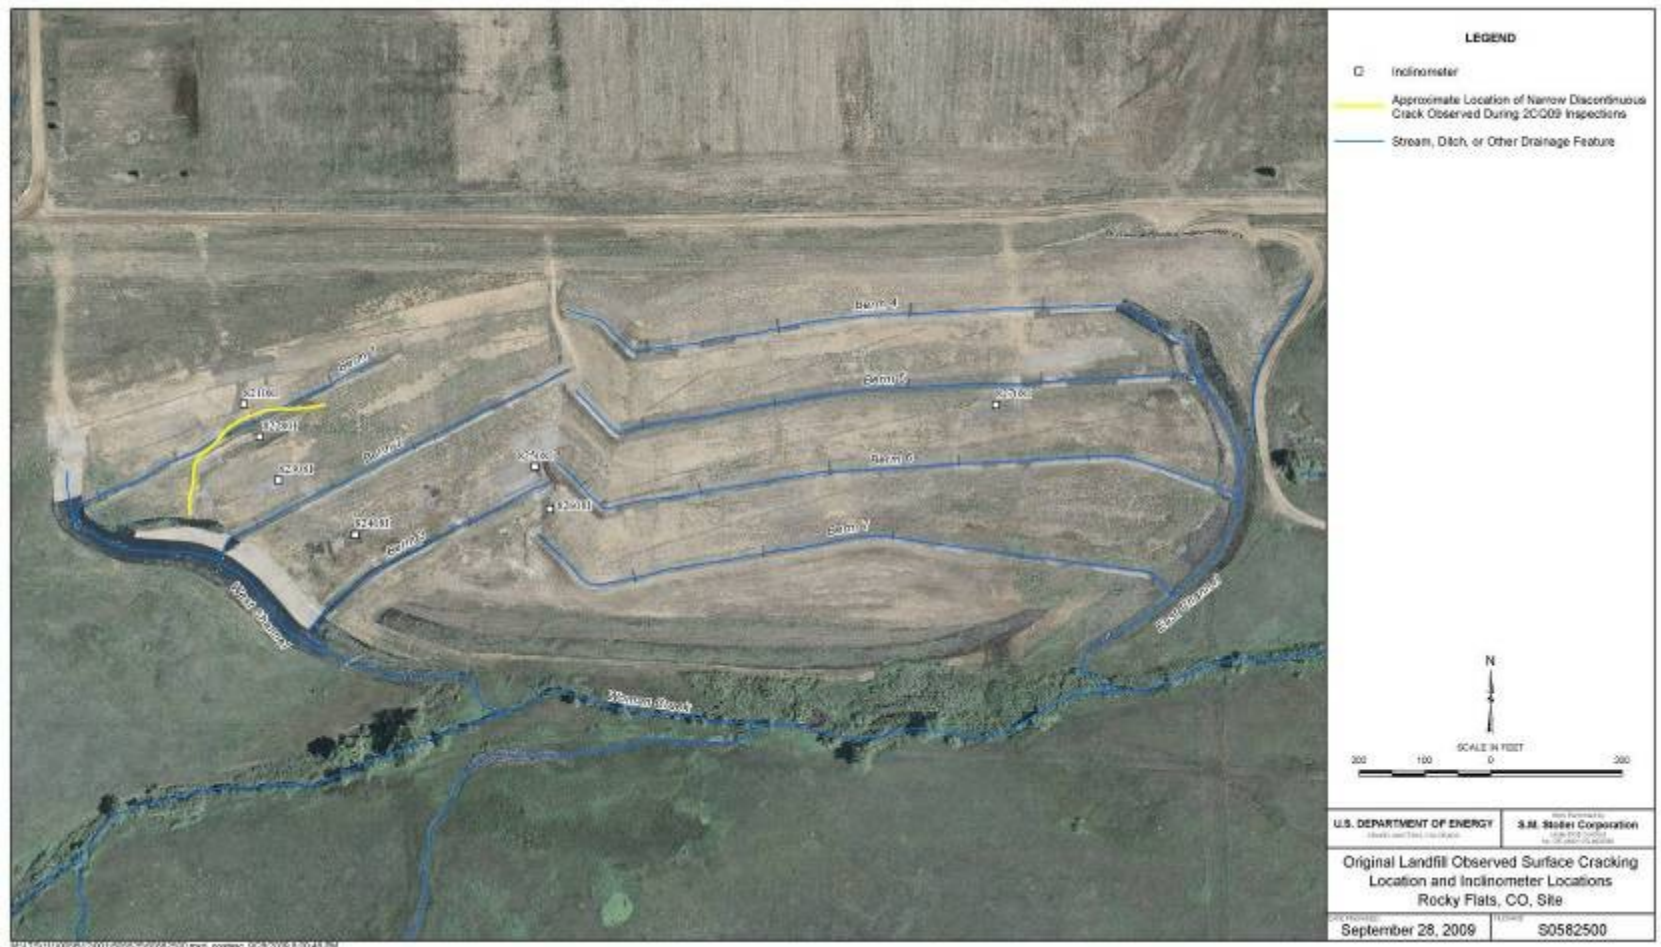
# OLF Observed Crack Location

- Areas where the landfill cover is pushed up or rolling are noticeable on the western end of the OLF between Berms 2 and 3; however, the areas continue to remain free of any surface cracking
- A new 140-foot-long, narrow, continuous crack that runs along the north and south sides of Berm 1 was noticed during a nonroutine inspection of the OLF on July 22
  - This crack is in the same general location of large cracks that appeared in 2006 and 2007 and observed again during second quarter 2009
  - The crack was filled and compacted with Rocky Flats Alluvium on July 22; subsequent inspections throughout the third quarter showed no new movement
